Manhole Inspection Summary

Manhole # S31CC_041MH

Location Address: **900 MADISON AVE**

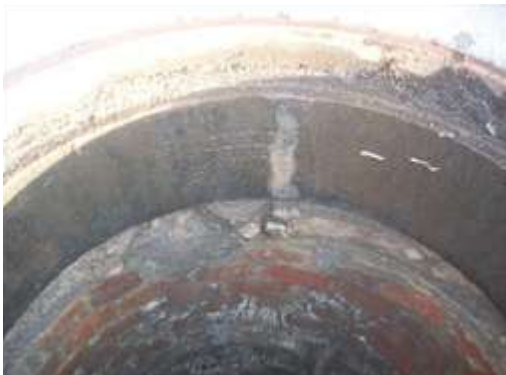
Defect 2

Condition: ☐ Sound ☐ Cracked ☐ Root Intrusion ☐ Loose Brick ☒ **Deteriorated**

CHIMNEY DETERIORATION

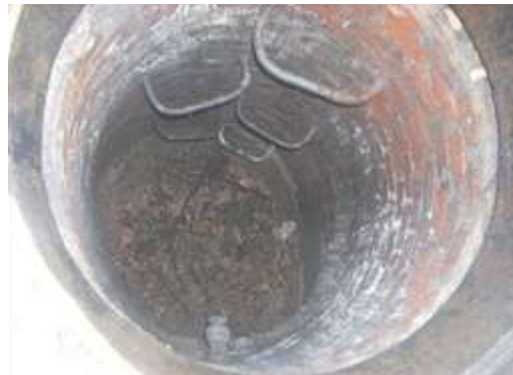
Defect 1

Count: **5** Missing: **0** ☒ **Corroded**

CORRODED STEP

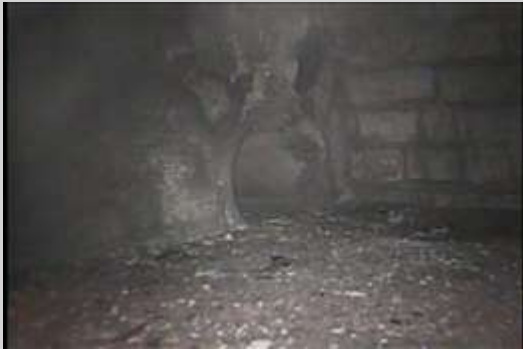
12 O'Clock Outflow

8 in. Circular Gravity Sewer
Pipe Out @ 12 O'Clock

Infiltration: **None** Pipe Seal Cond: **Sound**
